**Dutch Slough Tidal Marsh Restoration Project
Preliminary Opportunities and Constraints Report**

The California State Coastal Conservancy

Natural Heritage Institute
2140 Shattuck Ave, Suite 500
Berkeley, CA 94704
(510) 644-2900

February 20, 2004

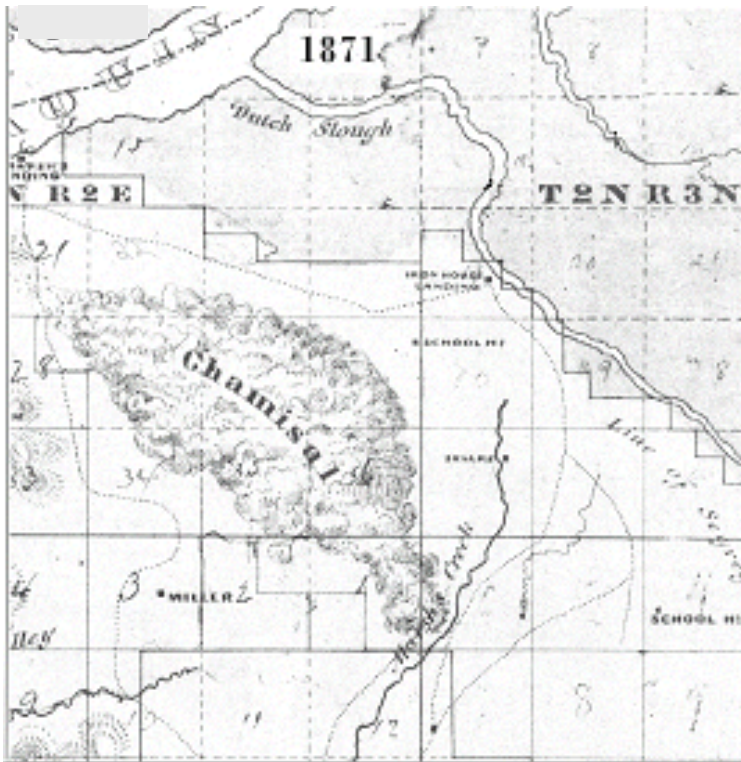
Figure 3c. 1871 historical map and hydrography of the Dutch Slough area.
 Courtesy of State Geological and US Survey.

Prior to European settlement, the Dutch Slough site was a tidal marsh bordered by seasonal and riparian wetlands and Pleistocene dunes at the historic delta of Marsh Creek. The parcels were diked and drained for agriculture during the nineteenth century, perhaps as early as the 1850's. Emerson, Little Dutch Slough, and the eastern portion of Dutch Slough are all artificial channels that were dredged between 1904 and 1910. These artificial channels displaced a pre-existing channel network that was more sinuous and irregular. The only information on the location and character of the original channels comes from four small-scale maps from 1850 to 1908 that all depict different configurations (Figures 3a-3d).

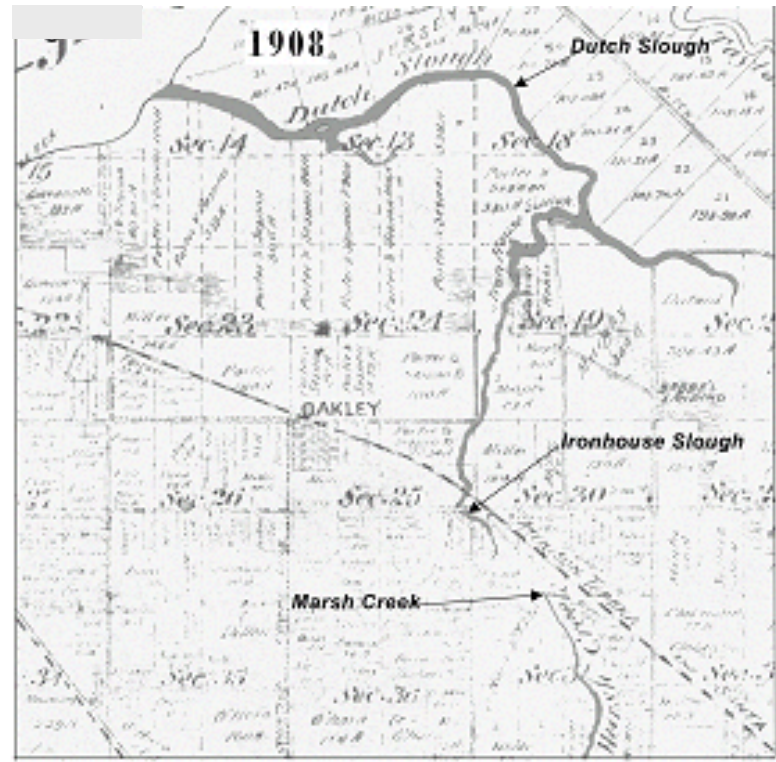
Figure 3d. 1908 historical map and hydrography of the Dutch Slough area.
 Courtesy of McMahon.

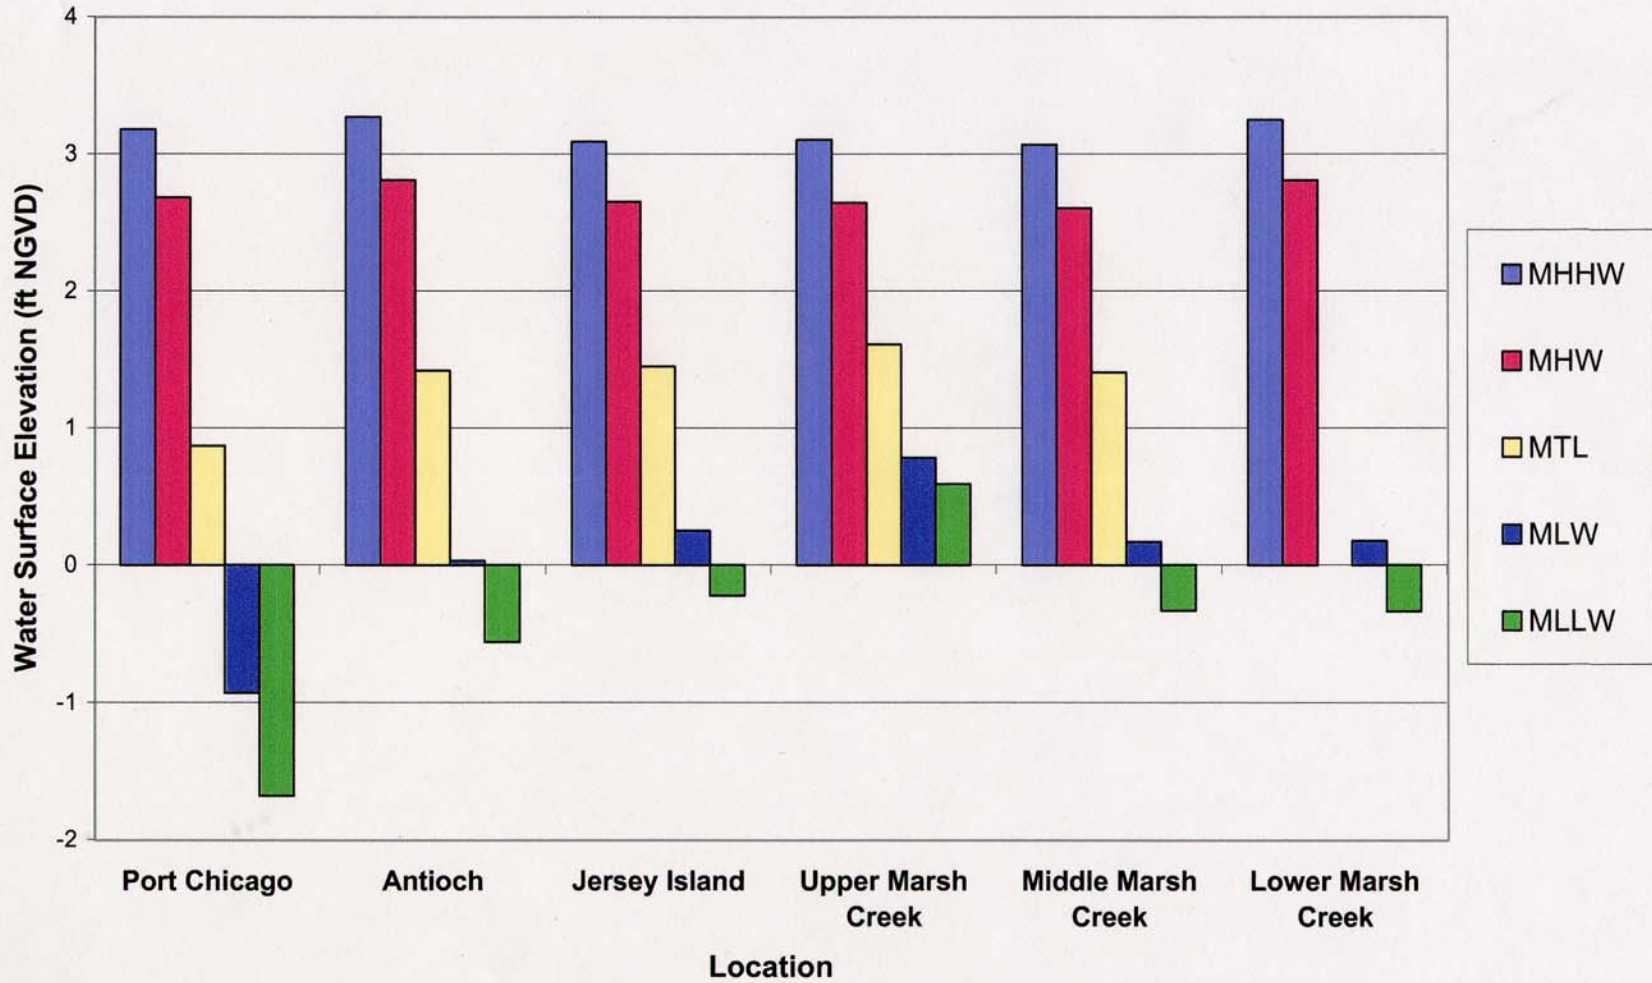
Tidal Datums at Marsh Creek and Three NOS Stations

Figure 8. Tidal range at Dutch Slough.

Large areas of tidal marsh can be restored on all three of the Dutch Slough parcels by simply breaching the existing levees. The tidal range in the vicinity of Dutch Slough is approximately 3.3 feet (Figure 8). Due to the large cross sectional area of the existing channels along Emerson and Little Dutch Sloughs (Figure 9), it is probably possible to establish the full tidal range on the Dutch Slough parcels without enlarging the existing sloughs. More specific information about the slough bathymetry is necessary to confirm this assumption. With the existing topography, only about one quarter of the site would revert to inter-tidal¹ marsh if tidal inundation were restored. The remainder of the site is either too high or too low for establishment of inter-tidal marsh and would thus become a combination of open water, sub-tidal emergent marsh, seasonal wetlands and floodplain, and uplands.

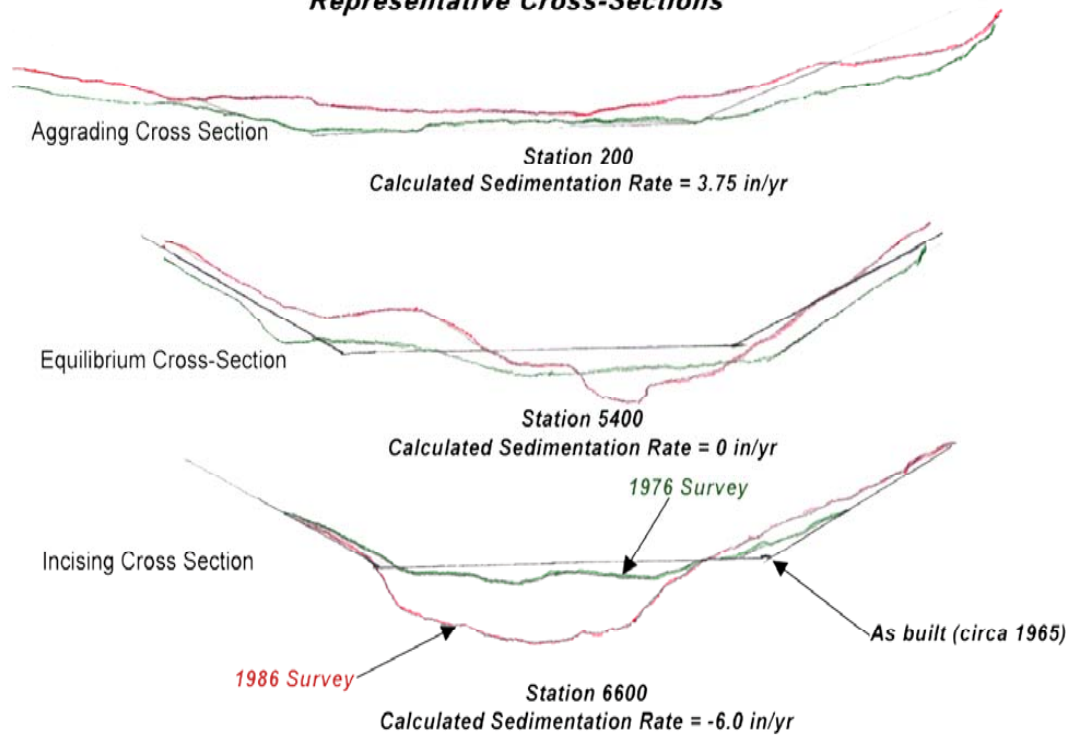
Figure 16. Sedimentation survey cross-sections of Marsh Creek and map of cross-section locations.

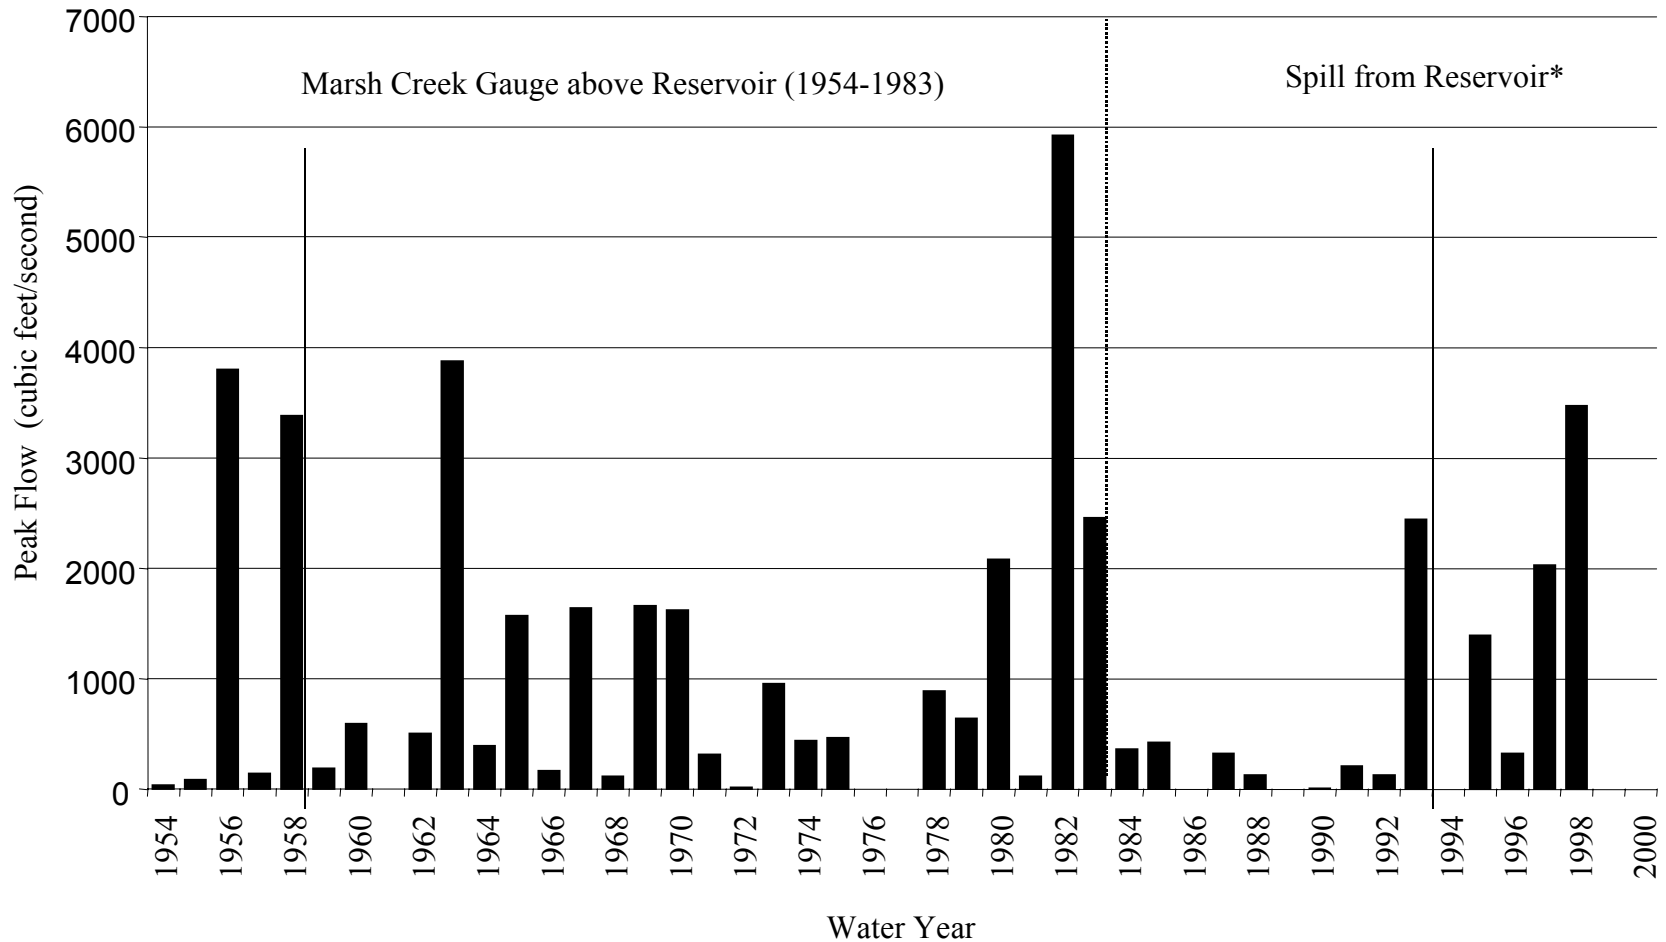
Figure 18. Annual maximum peak flows for Marsh Creek. *Peaks muted by Marsh Creek Dam, but include inflow from Briones Creek.

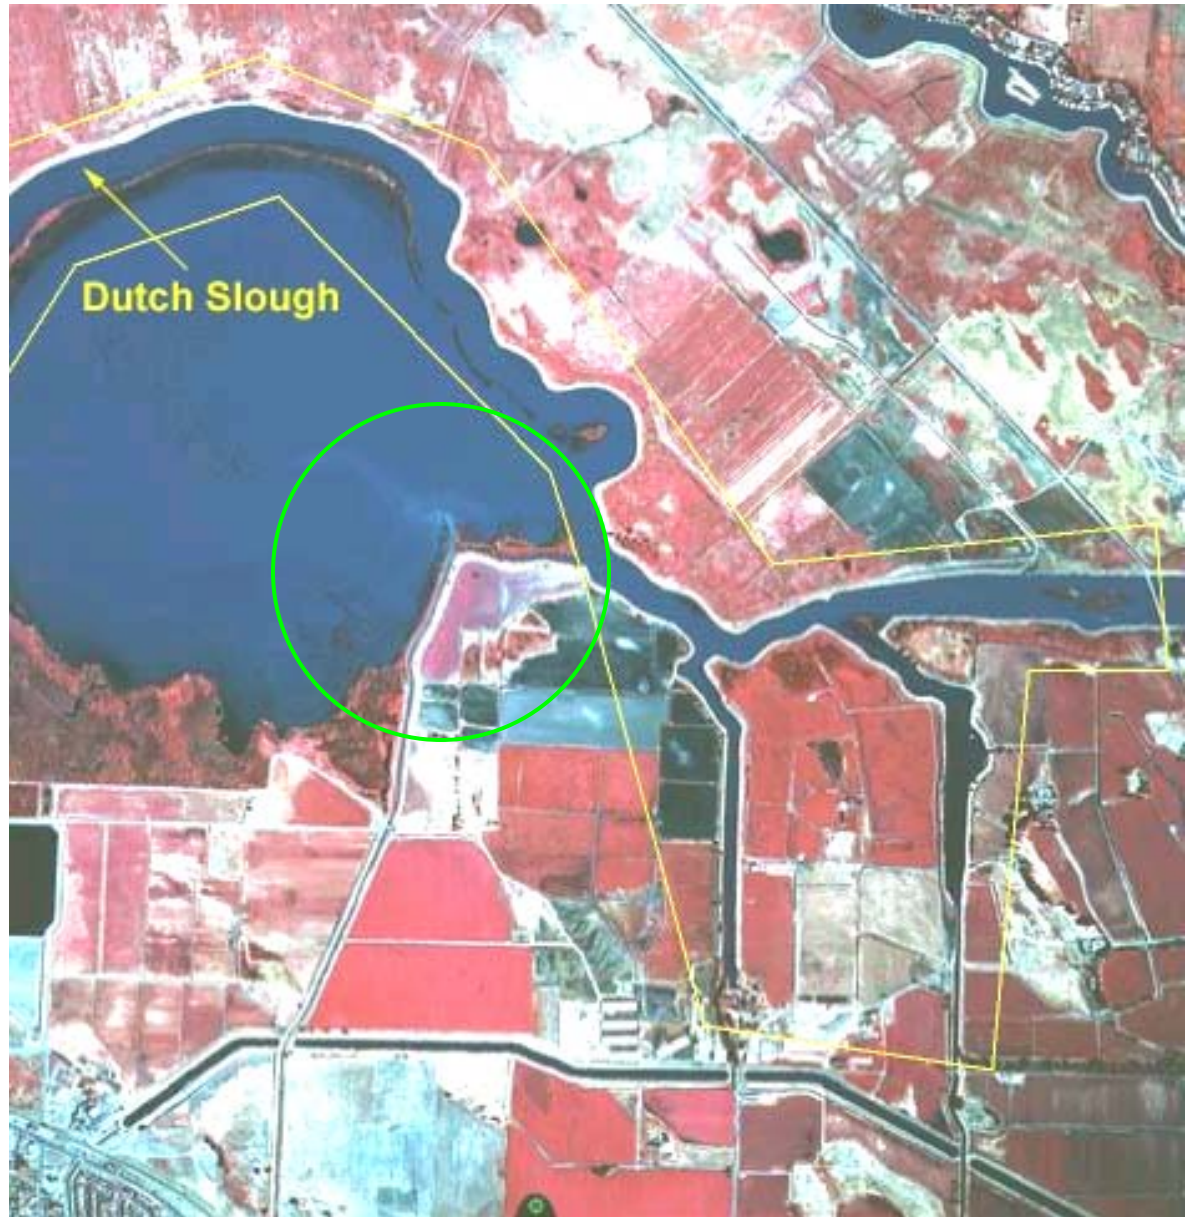
Figure 20. August 1999 aerial photo of Marsh Creek sediment plume. Imagery copyrighted and owned by California Department of Boating and Waterways and SFSU Romberg Tiburon Center for Environmental Studies.
